REPORT NO: NAWCADPAX/RTR-2000/97

S-3B SMALL-SCALE APPLIQUÉ COUPON FLIGHT TEST EVALUATION RESULTS

9 January 2001

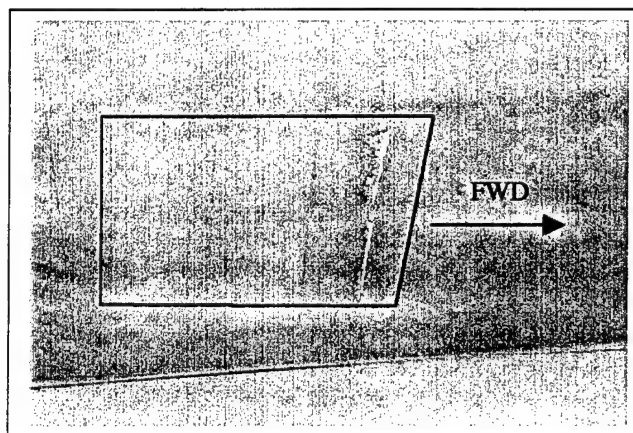
Following the failure mode test flight, the prepeeled coupons at site 1 were inspected. Figure 8 shows the prepeeled coupons at site 1 on the left wing following the flight, and figure 9 shows the prepeeled coupons at site 1 on the right wing following the flight. Neither the FP500 nor FP1500 material experienced any additional peeling, and the film tattered as desired.

Figure 8: Prepeeled coupons at site 1 on left wing following flight. (Test site outlined in black.)

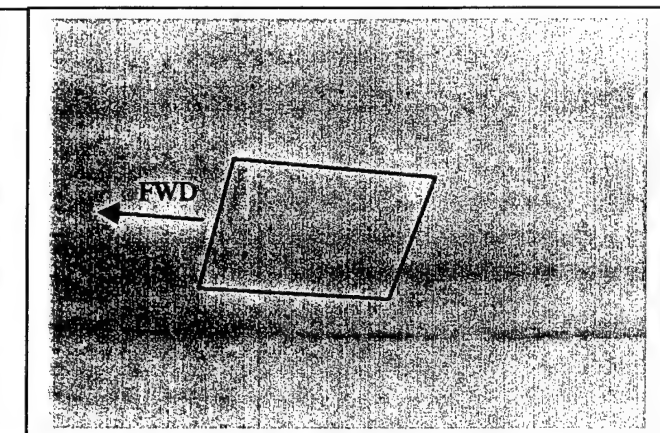
Figure 9: Prepeeled coupons at site 1 on right wing following flight. (Test site outlined in black.)

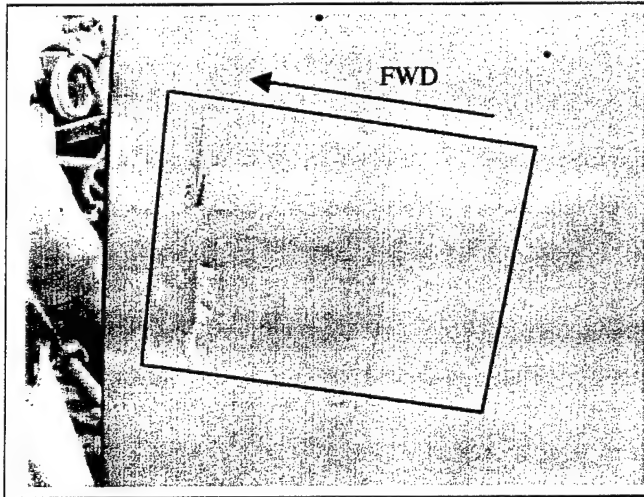
Figure 10: Prepeeled coupons at site 2 on the left lower gear door prior to the flight. (Test site outlined in black)

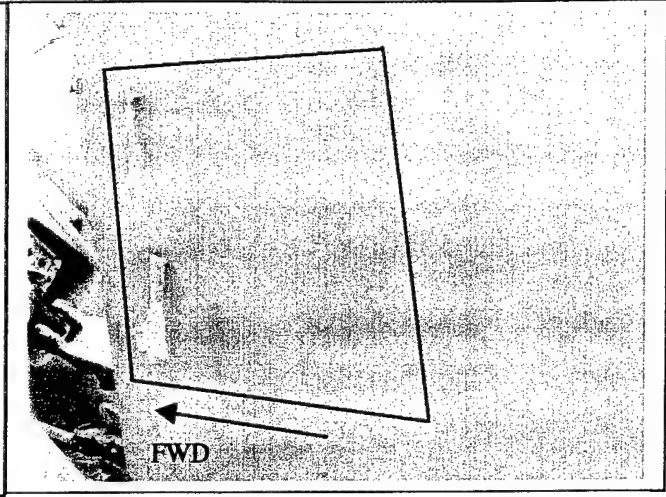
Figure 11: Prepeeled coupons at site 2 on the right lower gear door prior to the flight. (Test site outlined in black)

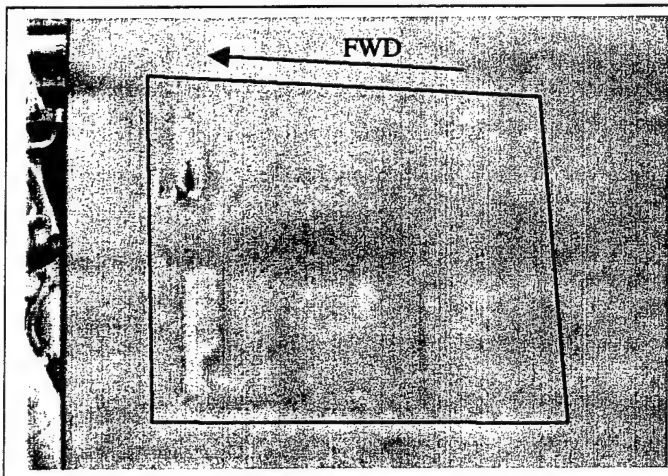
Following the failure mode test flight, the prepeeled coupons at site 2 were inspected. Figure 12 shows the prepeeled coupons at site 2 on the left lower gear door following the flight, and figure 13 shows the prepeeled coupons at site 2 on the right lower gear door following the flight. Neither the FP500 nor FP1500 material experienced any additional peeling, and the film tattered as desired.

Figure 12: Prepeeled coupons at site 2 on the left lower gear door following the flight. (Test site outlined in black.)

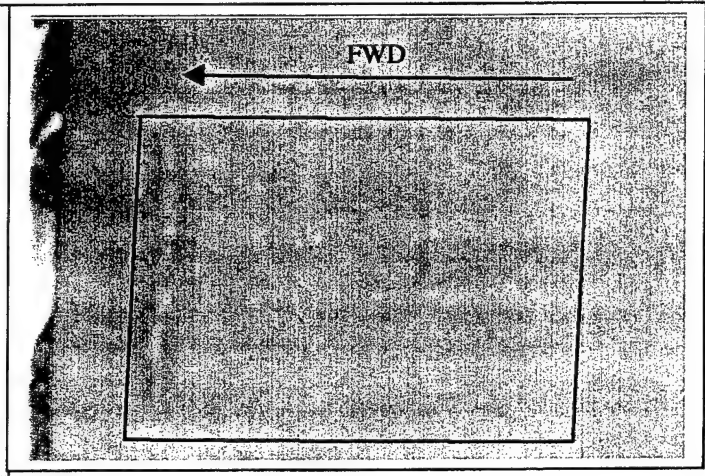
Figure 13: Prepeeled coupons at site 2 on the right lower gear door following the flight. (Test site outlined in black.)

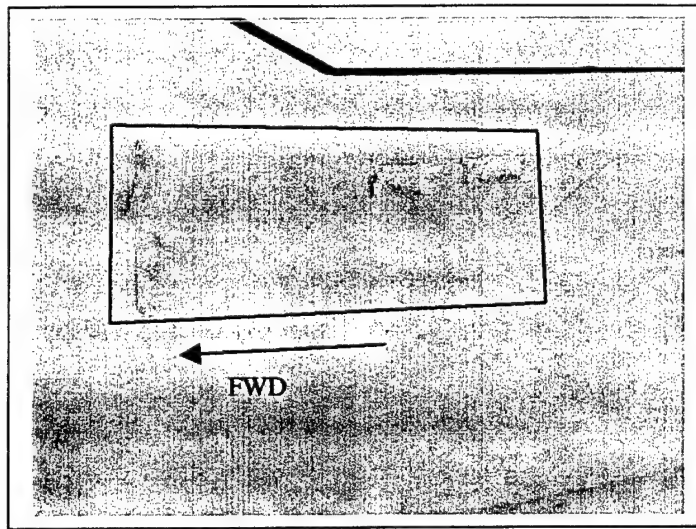
Figure 14: Prepeeled coupons at site 3 on the vertical tail below the rudder prior to flight.

Following the failure mode test flight, the prepeeled coupons at site 3 were inspected. A photograph showing the prepeeled coupons at site 3 following the flight was not available. However, neither the FP500 nor FP1500 material experienced any additional peeling, and the film tattered as desired.
